# Manhole Inspection Summary

Manhole # S21W\_\_009MH

Insp Date: **4/16/09 1:38 PM**

**Location** Address: **GWYNNS FALLS TRAIL**

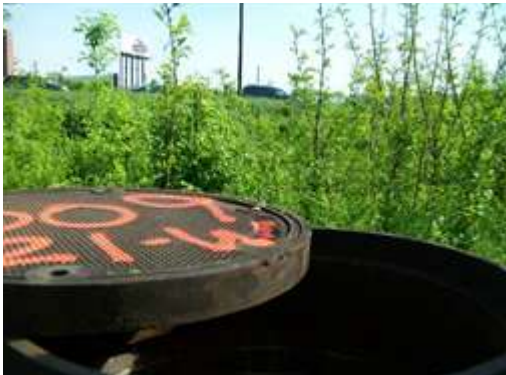
Location View

LOOKING TOWARDS 195

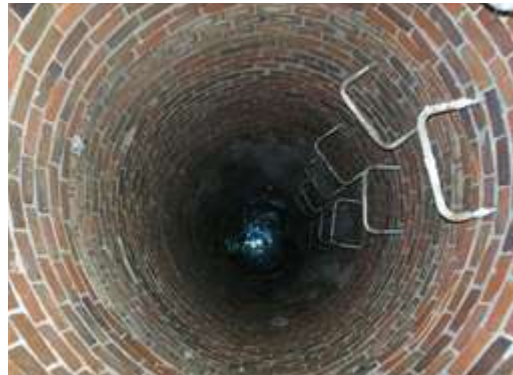
Top View

Due to the depth of the manhole & the size of the pipe @ the bottom of the manhole, this was the clearest top view

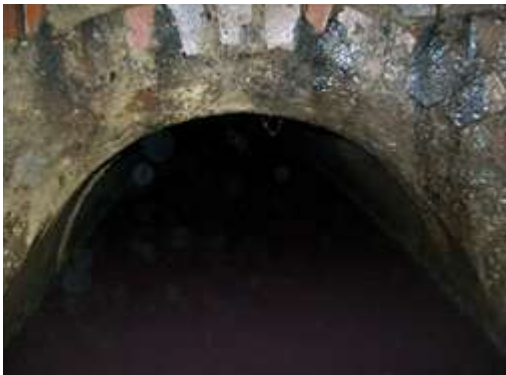
Defect 1

Infiltration: ☐ None ☐ Joint ☐ Cracks ☒ **Mortar** ☐ Roots ☐ Wall

Infiltration in barrel near pipe connections

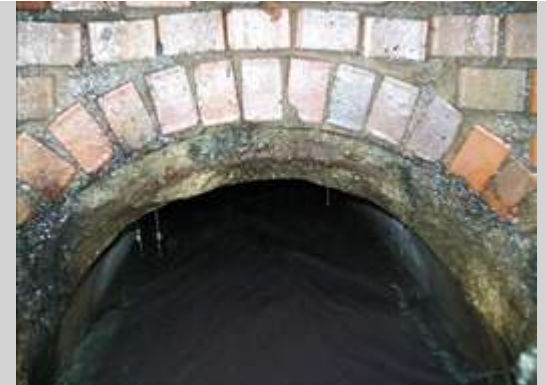
12 O'Clock Outflow

30 in. Circular Gravity Sewer  
Pipe Out @ 12 O'Clock

Pipe Material: **Concrete** ☐ Pipe Lined

Invert Depth: **43.74** (ft.) Flow Characteristics: **Fast**

Deposits: ☒ None ☐ Mud ☐ Sludge ☐ Debris ☐ Grease

Infiltration: **None** Pipe Seal Cond: **Sound**

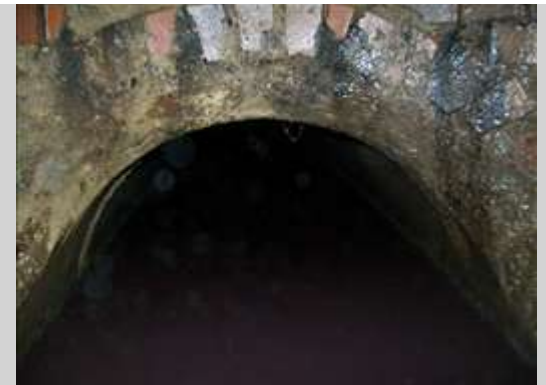
6 O'Clock Inflow

30 in. Circular Gravity Sewer  
Pipe In @ 6 O'Clock

Pipe Material: **Concrete** ☐ Pipe Lined

Invert Depth: **43.68** (ft.) Flow Characteristics: **Fast**

Deposits: ☒ None ☐ Mud ☐ Sludge ☐ Debris ☐ Grease

Infiltration: **None** Pipe Seal Cond: **Sound**

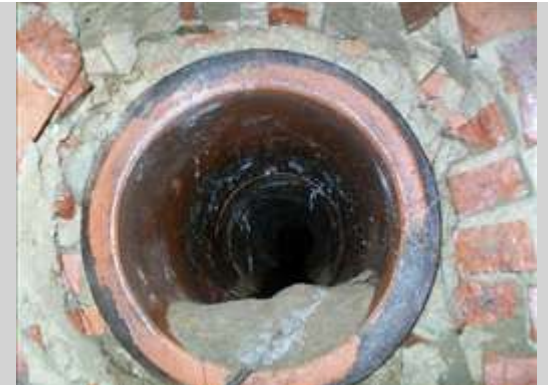
9 O'Clock Inflow

10 in. Circular Gravity Sewer

Pipe In @ 9 O'Clock

Pipe Material: **Clay** ☐ Pipe Lined

Invert Depth: **34.14** (ft.) Flow Characteristics: **Slow**

Infiltration: **None** Pipe Seal Cond: **Sound**

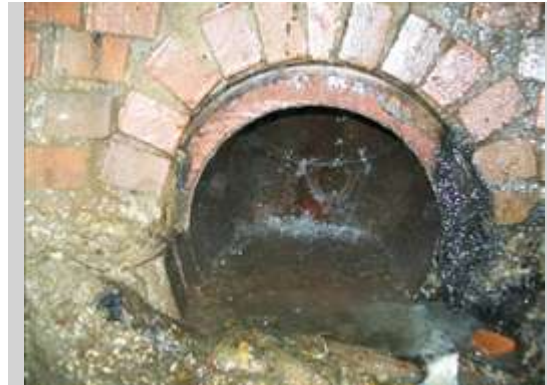
Drop In @ 9 O'Clock

Drop: **Inside** **Direct**

Inv Depth: **41.39** (ft.)

Drop Condition: **Open**
